# Value Proposition of Polyketone Liners & Continuous Rod in Deviated Wells

Zach Stearman: Author

October 7, 2017

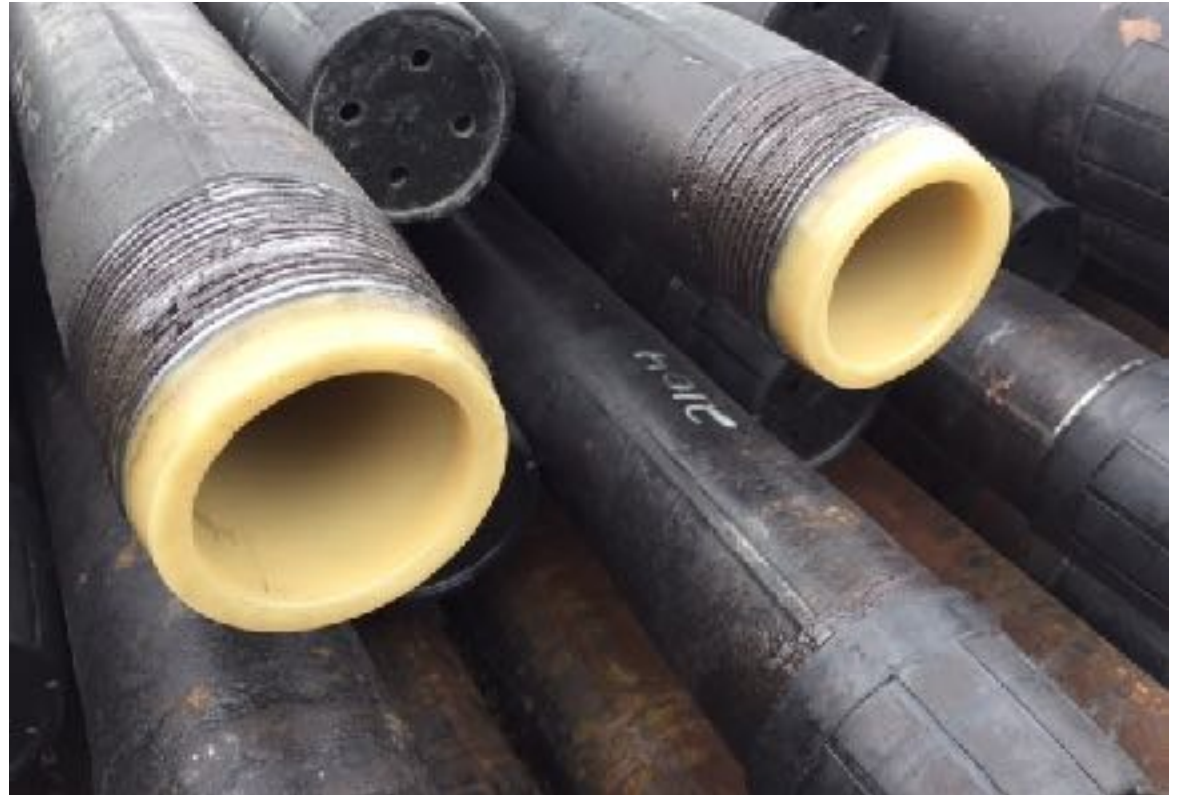
# Potential Benefits of Thermoplastic Liners

- Prevents rod on tubing contact, eliminating steel on steel wear
- Does not allow corrosive fluids to continuously erode tubing
- Protects tubing from exposure to abrasive solids
- Holiday-free to prevent localized corrosion attack

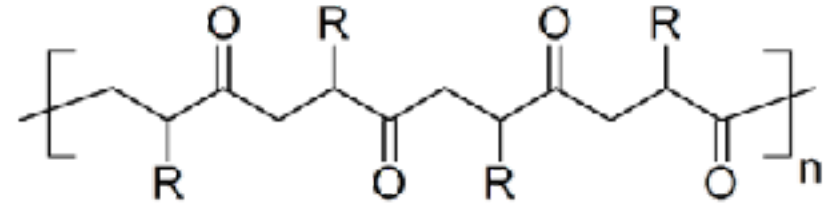
# Polyolefin Ketone Resin (POK)

- Unique engineering plastic with a carbon-only backbone
- Highly crystalline with a compact crystal structure
- Stable at high temperatures
- Has excellent abrasion/chemical/fuel resistance
- Gas barrier properties
- Physical and chemical properties make the resin well suited for downhole applications

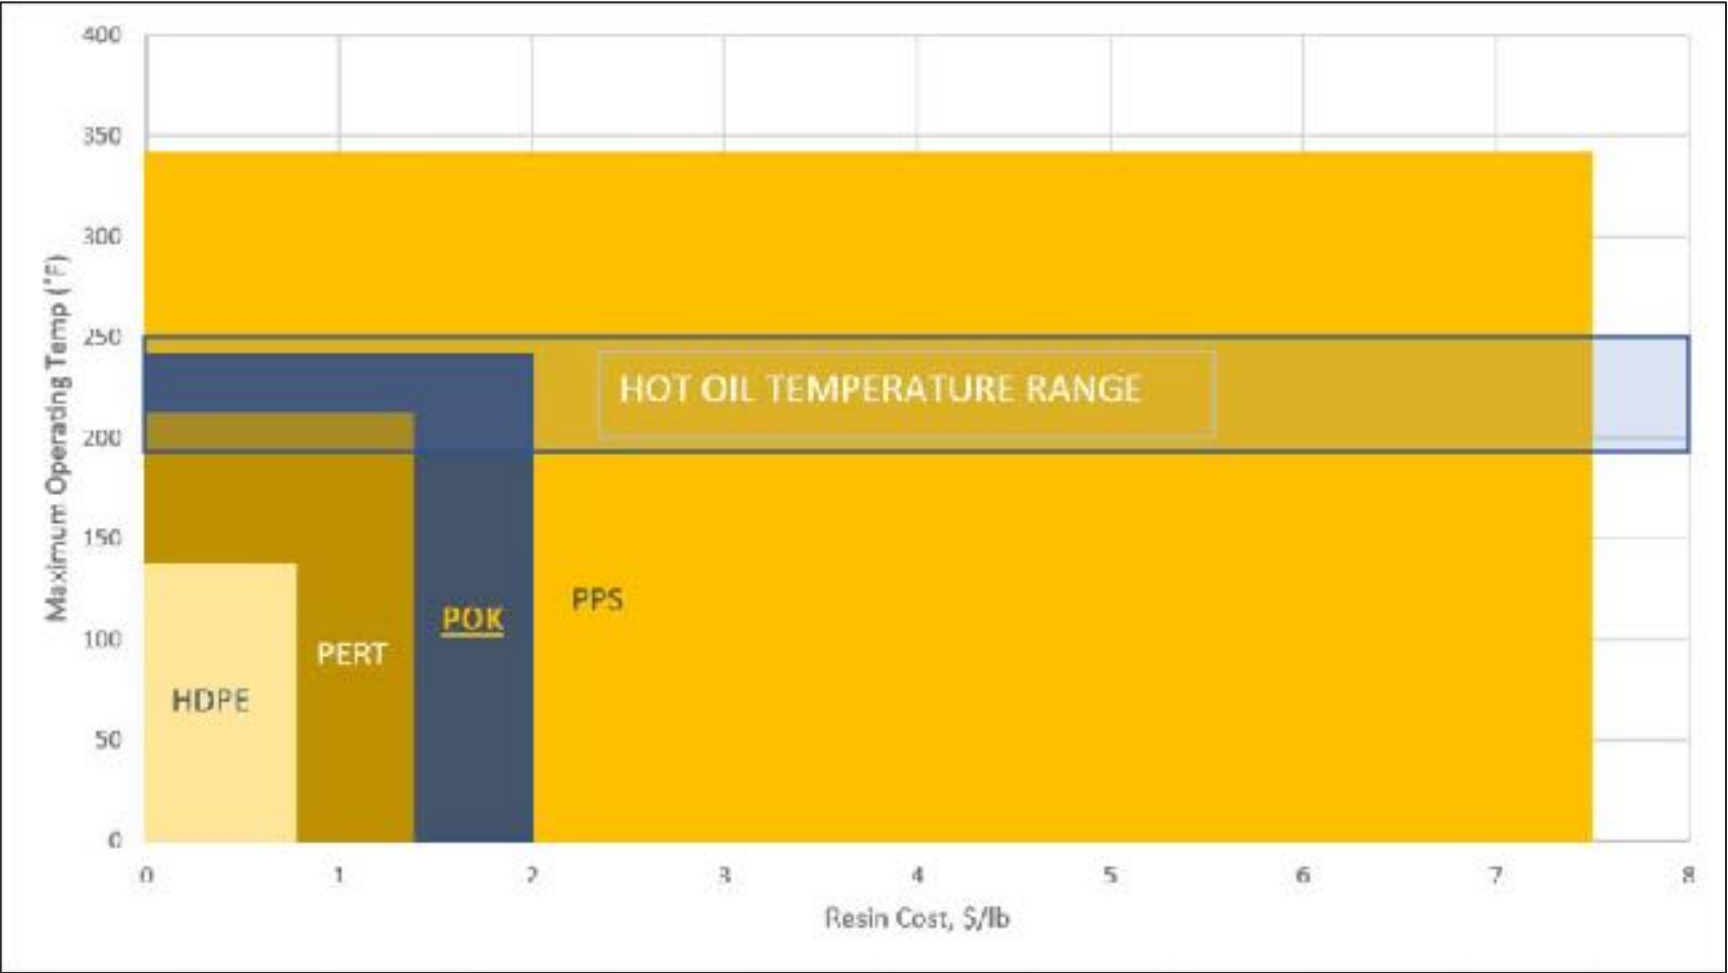
# Resin Working Temperature vs Cost

General Specifications					
Material Type	Max Temp.	Dimensions	H <sub>2</sub> S	CO <sub>2</sub>	Cost
HDPE	140° F	2 3/8" - 4 1/2"	2%	10%	\$
HDPE - Modified	210° F	2 3/8" - 4 1/2"	2%	10%	\$\$
<b>POK - Modified</b>	<b>240° F</b>	<b>2 3/8" - 4 1/2"</b>	<b>5%</b>	<b>20%</b>	<b>\$\$</b>
PPS - Modified	340° F	2 3/8" - 4 1/2"	5%	20%	\$\$\$\$
PEEK	500° F	2 3/8" - 4 1/2"	5%	20%	\$\$\$\$\$

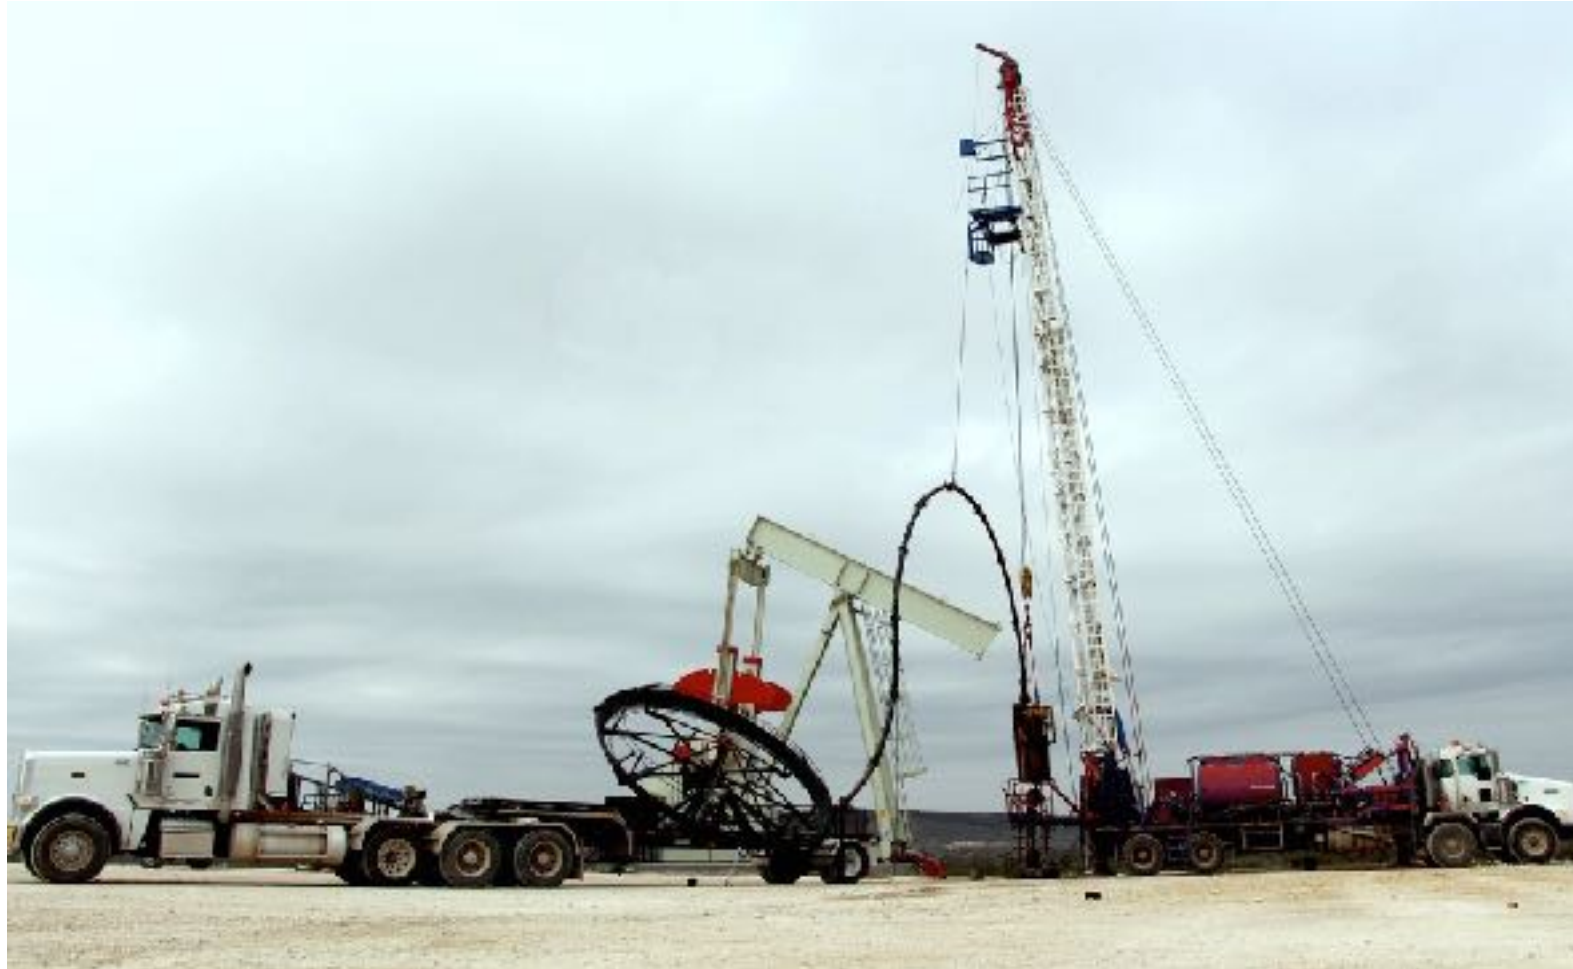
# Continuous Rod Installation

- Side Load Distributed over Entire String, Not on Coupling Alone
- No Reduced Flow Area around Couplings
  - Reduce breakout of corrosive elements due to turbulent flow around couplings and rod guides
  - Potentially increase production with less flow restriction in the tubing
- Eliminate Care & Handling Failures and Improper Makeup
- Fast, Easy Installation

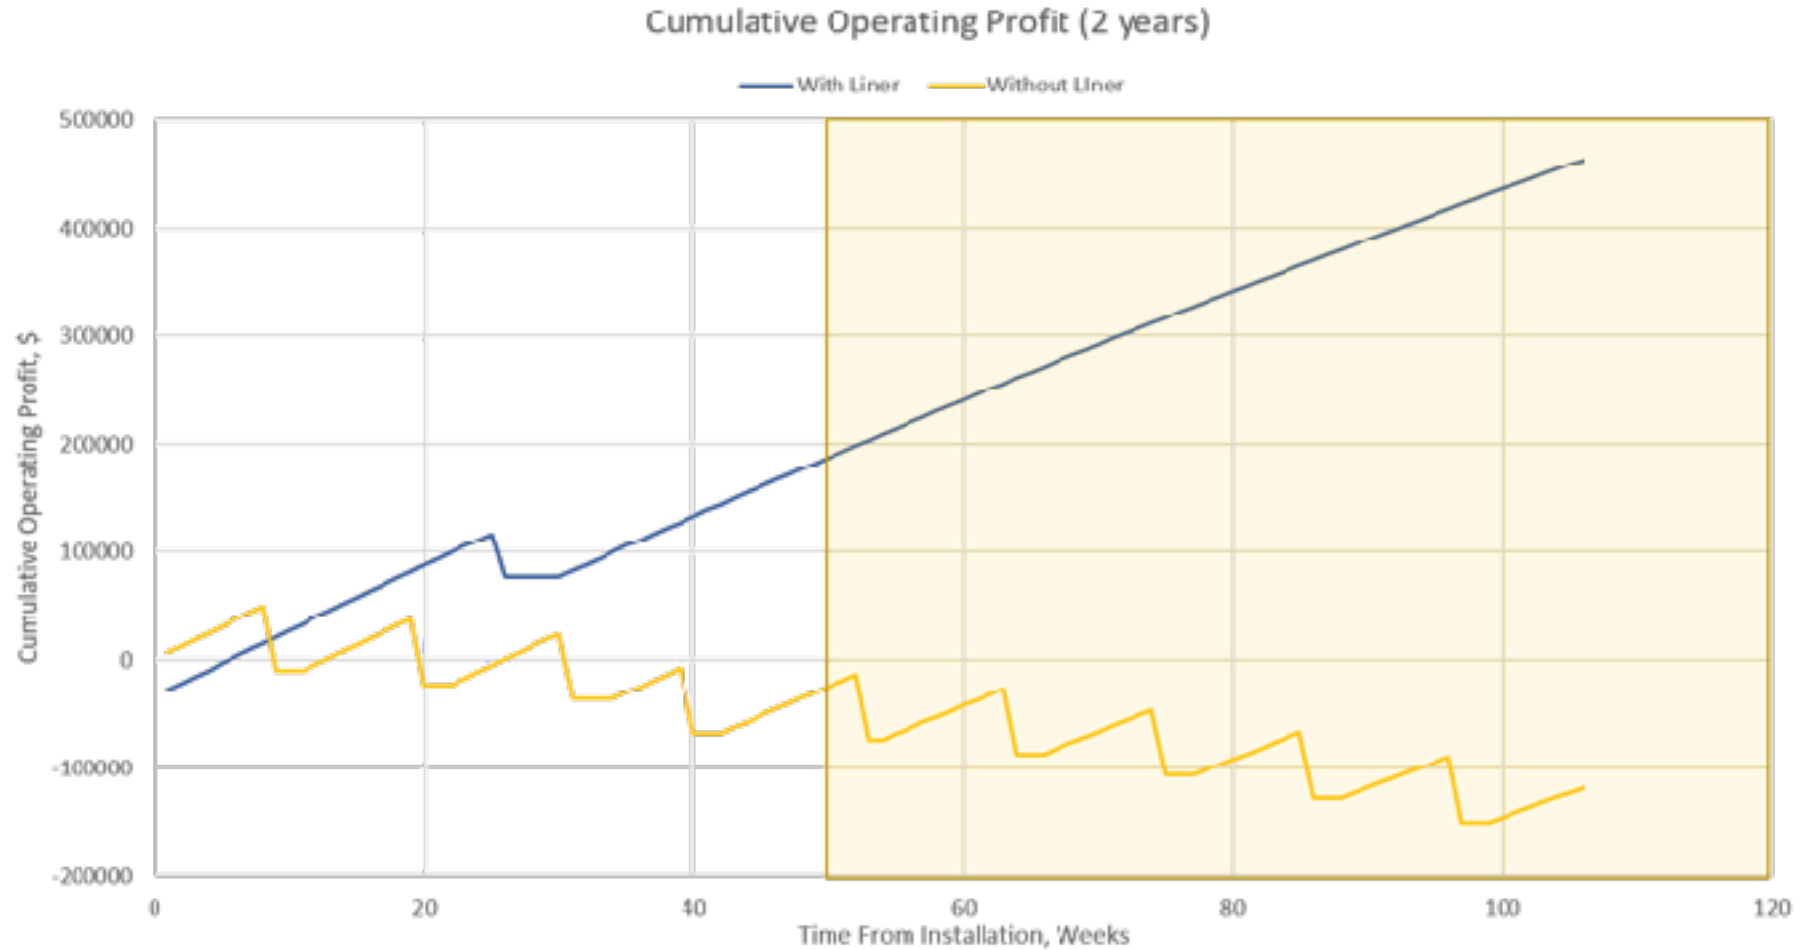
# Case Study 1 – Cumulative Operating Profit

• Base tubing workover cost	\$60,000
• Liner Cost per Foot	\$5.73
• Oil Price per Barrel	\$40
• Oil Production Rate (BPD)	30
• Lifting Cost per Barrel	\$10
• Annual Production Decline Rate	10%
• Downtime per Failure (days)	21
• Previous MTBF (months)	2
<hr/>	
• Failures Saved to Date	4.38
• Lost Production Revenue per Failure	\$18,900
• Total Savings per Failure	\$78,900
<hr/>	
• <b>Total Savings Less Investment to Date</b>	<b>\$311,465</b>
• <b>ROI to Date</b>	<b>906%</b>

\* Annual Decline Rate = 10%, Annual Discount Rate = 7%

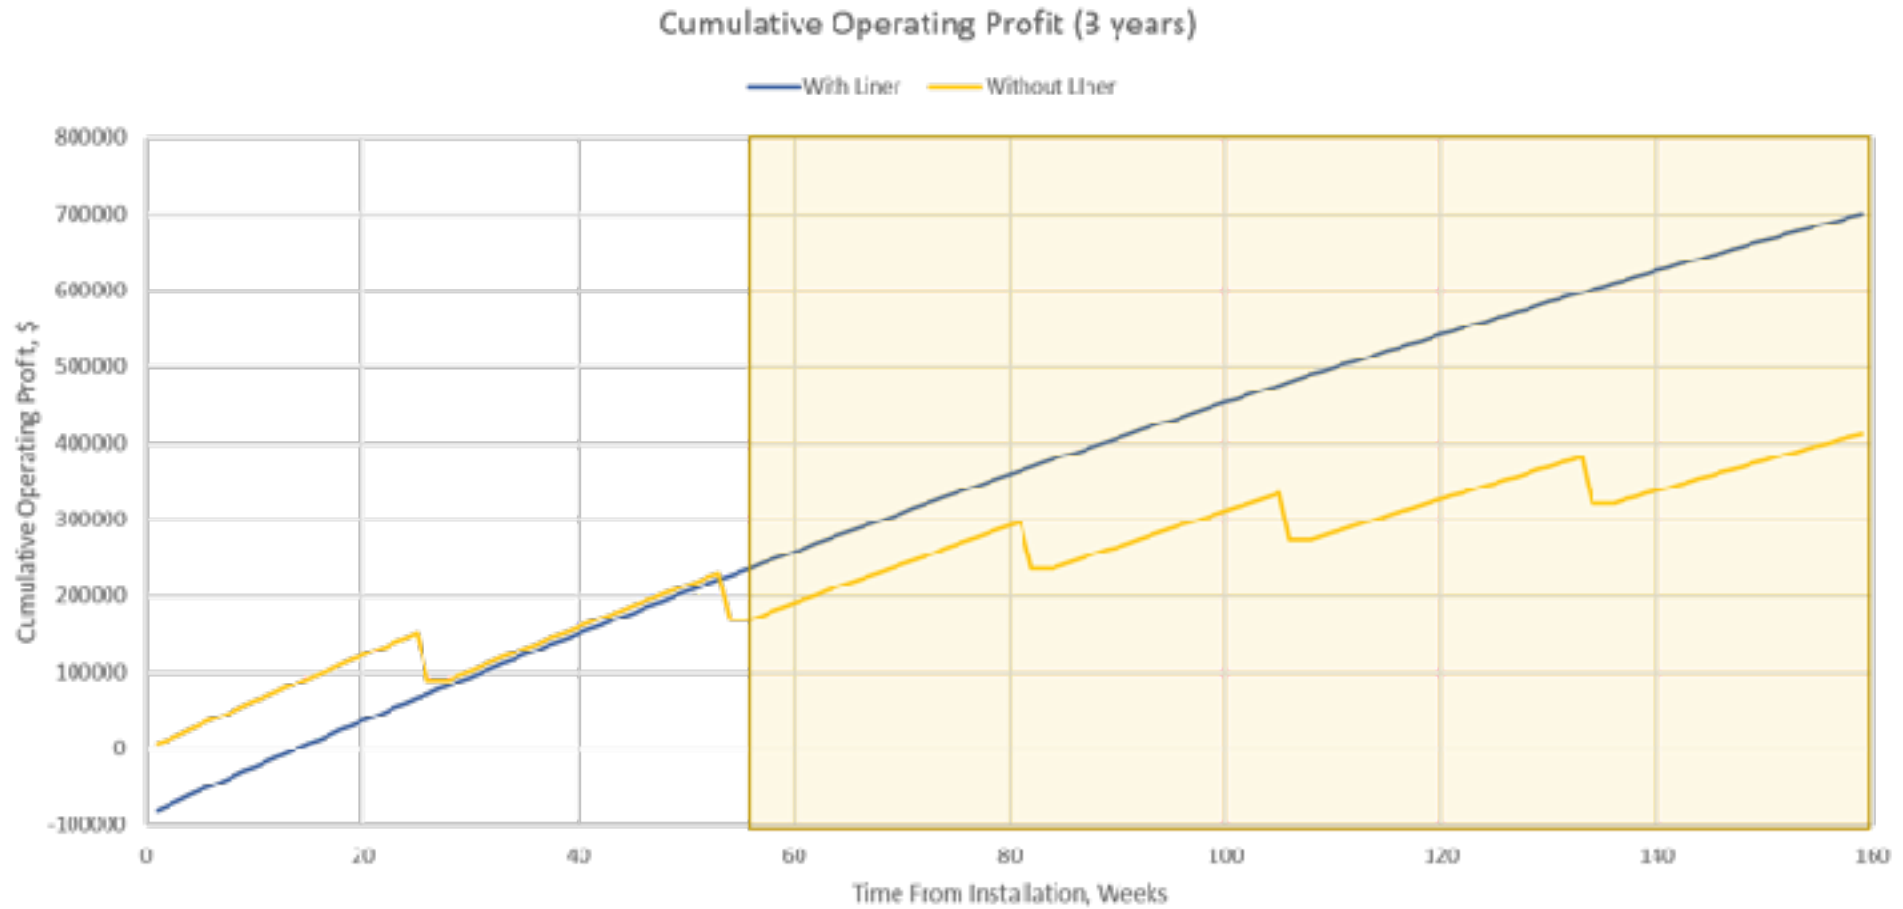
# Case Study 2 – Cumulative Operating Profit

• Base tubing workover cost	\$60,000
• Liner Cost per Foot (blended)	\$7.57
• Initial Continuous Rod Investment	\$20,000
• Oil Price per Barrel	\$40
• Oil Production Rate (BPD)	30
• Lifting Cost per Barrel	\$10
• Annual Production Decline Rate	10%
• Downtime per Failure (days)	21
• Previous MTBF (months)	6
<hr/>	
• Failures Saved to Date	1.244
• Lost Production Revenue per Failure	\$12,600
• Total Savings per Failure	\$72,600
<hr/>	
• <b>Total Savings Less Investment to Date</b>	<b>\$12,486.67</b>
• <b>ROI to Date</b>	<b>15%</b>

\* Annual Decline Rate = 10%, Annual Discount Rate = 7%
