# LPS NEWSLETTER

## CONTINUOUS ROD AND TUBING LINER UPDATE

Volume 1 / Issue 1

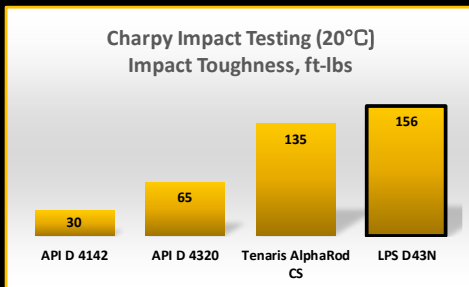
The “Charpy Impact Testing” graph tested by an independent 3rd party lab shows LightningRod™ to have superior toughness compared with industry standard rods.

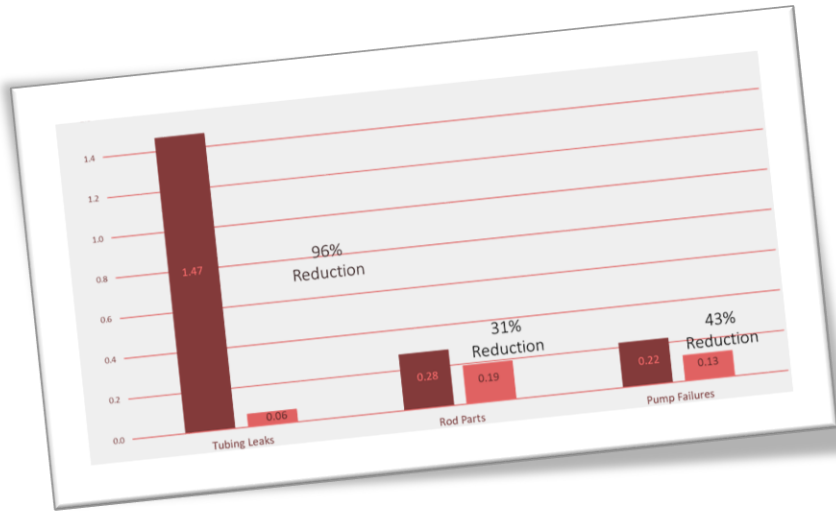
# LightningFlo™ Case Study

LPS has worked with an operator in West Texas with both product lines. LightningFlo™ lined tubing was installed in 13 wells in the Permian Basin from September 2016 to the end of 2018. These wells had major deviation, causing a high failure rate. The average well depth was 11,500'. Wells used a combination of continuous rod and lined tubing.

The results show a dramatic decrease in failure rate when using LightningFlo™ lined tubing. The tubing failures were nearly eliminated entirely, and a slight improvement was seen in both the rod and pump failure rates. The reduction in failure gave the operator an average savings of \$134,400/well/year in workover costs alone.

The drastic increase in performance resulted in the operator implementing a field wide lined tubing plan. Any well with 2+ failures in the previous 12 months and making less than 250 bpd of fluid is now equipped with LPS lined tubing.
